# A case study on slope instability of Punatshangchhu Hydroelectric Project Authority-I Dam in Bhutan

**Rinchen Lhamo**

## **Abstract**

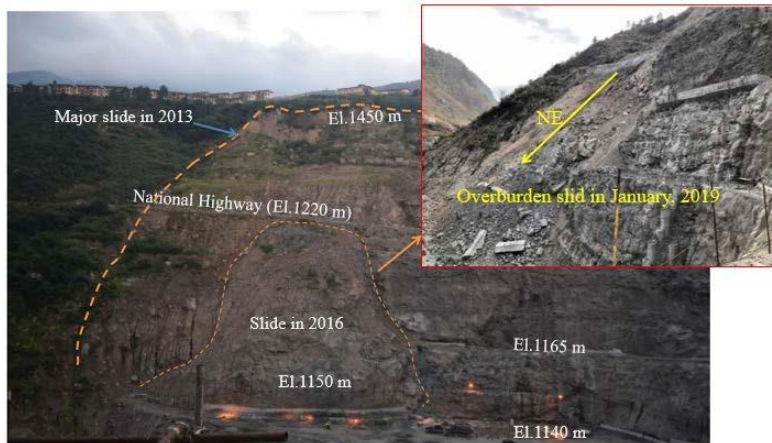
Since the start of project in 2008, first sign of instability of right abutment of PHPA-I occurred in 2011 (NGI, 2017). Excavation work came to a hold in July 2013, when the hill mass of right bank started sliding towards the dam pit. The maximum movement was up to 4 m and crown of the slide extended up to El.1,450 m and the toe of the slide lies between El.1,110 m and 1,090 m, from 150 m upstream to 140 m downstream of dam axis. Due to the movement of slope, opening of joints and cracks were observed with opening between 2 to 40 cm. Uplift of floors and deformed ribs in the grouting gallery (El.1,169m) were first observed as instability sign.

Fig. 1. Slide boundary of right abutment of PPHA-I, Dam

The stabilization measures were carried out in accordance with technical solutions evolved by the designers, from above the dam top i.e. El. 1,205 m to El.1,340 m was completed as per schedule well before start of monsoon 2015. Series of preventive measures including grouting, cable anchor, RCC pile of 2 m diameter, micro pile (325 mm)

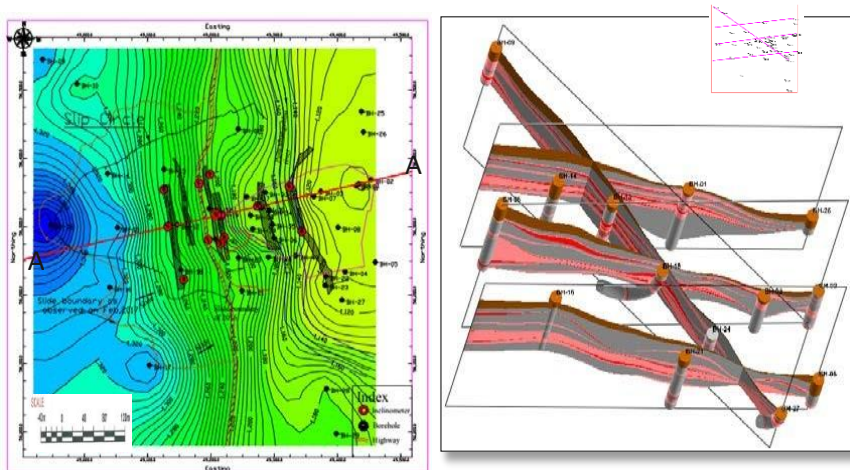
Fig. 3 Layout of boreholes (left) & 3D fence diagram (right)

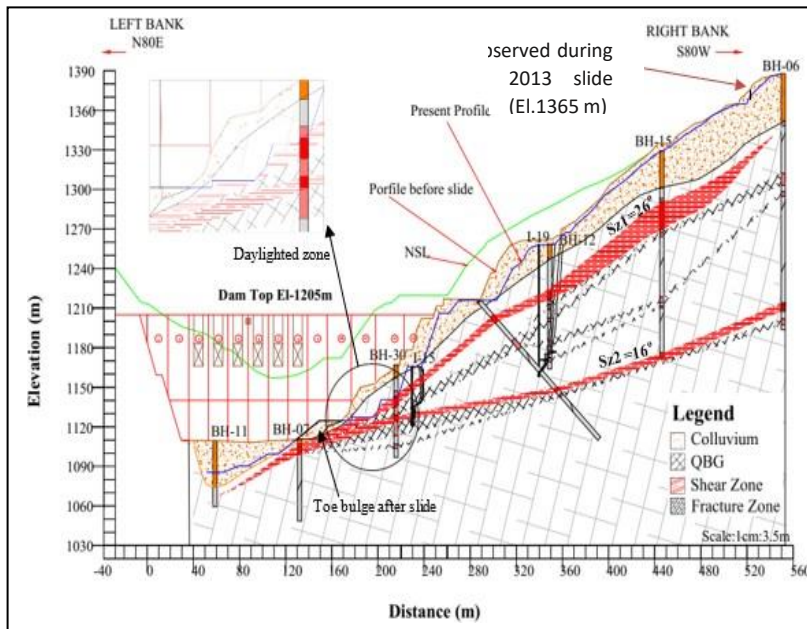
Fig. 4 2D Cross-section along Dam Axis (A-A')

the slip surface as illustrated in Fig. 4. The shear zone and fractured rock layer indicated by boring logs and the shearing plane indicated by the inclinometers conform to each other. The best way to describe the failure mechanism is that due to the presence of very weak shear zone layer with highly fractured rock mass dipping valleyward resulted in development of progressive failure. In addition, excavation at the toe of dam approximately at El.1,130 m to El.1,140 m led to daylighting of shear zone (Sz1) which caused the movement in July 2013.

Different intensities of fractures are present on this slope and same is represented in cross-section along the dam. The main shear zone (Sz1) dips at an average angle of  $26^\circ$  and Sz2 has average dipping angle of  $16^\circ$  whereas the face slope has average dipping angle of  $36^\circ$  (Fig. 4). Since the upper shear zone got daylighted towards face slope, it satisfies one condition of the planar failure criteria. Another criterion for planar failure mode is, dip angle of face slope should be greater than sliding plane which was also satisfied.

Bulging of toe area as illustrated in Fig. 4 is one of the significant indications of planar failure that occurred during 2013. With all the

conditions mentioned above, the mechanism of failure is planar failure along persistent discontinuity which is upper shear zone (Sz1).

PHPA-I has been facing challenges in arresting the slope movement of right bank of the dam, with the major slide happened in 2013. From the geotechnical investigation, rock mass on right bank consists of quartzofeldspathic gneiss with S-type folding & foliations with very thick colluvium (up to 34 m). Different intensities and thickness of shear zone and fractured zones were observed from the subsurface profile, with two prominent shear zones detected along the dam axis. Upper shear zone got daylighted towards face slope with its dip angle greater than sliding plane, thus concluded as planar failure along persistent discontinuity. The subsurface profile once constructed can be used for identifying the critical slip surface, modeling for slope stability analysis and generation of database for future use. Further excavation can be carried out after proper treatment of the shear zones.
